ASBESTOS AND REGULATED WASTE ASSESSMENT

3765 Bridge Street Northwest
St. Francis, Minnesota

Project # 7635

August 21, 2018

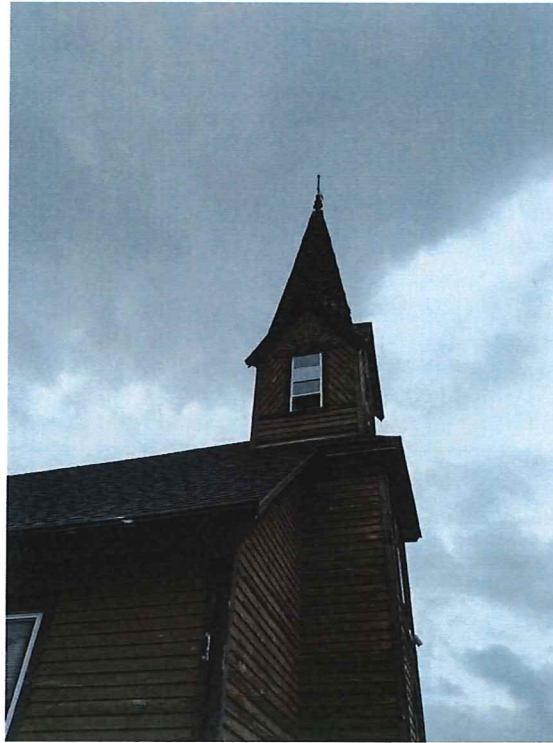
The light brown and dark brown paint on the steeple is considered lead-based paint. The paint is not regulated by Minnesota Department of Health; however, OSHA safe work practices must be employed during removal; and, if the paint is abated, any abatement waste must be managed and disposed of appropriately. In addition, it is recommended that the presence of lead-paint be disclosed to a prospective purchaser.

| Location Collected | Estimated Amount | Lead Quantity (%) |
|---|---|---|
| Light brown paint | 300 square feet | 18% |

| Location Collected | Estimated Amount | Lead Quantity (%) |
|---|---|---|
| Dark brown trim paint | 5 square feet | 4.7% |

Photograph 3 - View of the steeple.

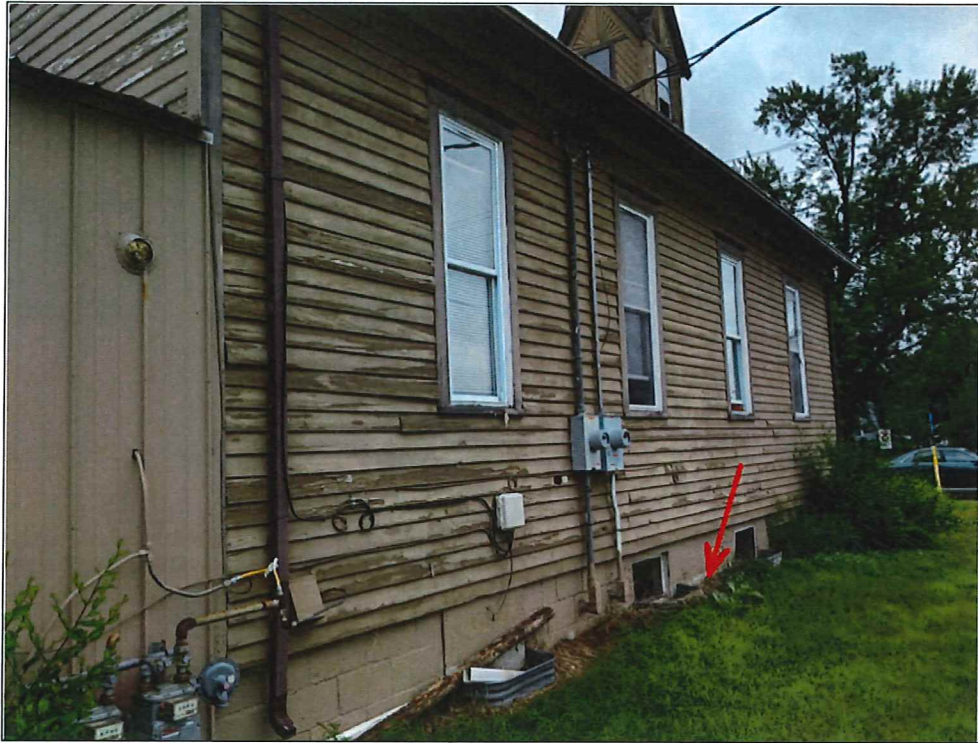
| Material Sampled | Estimate Amount | Asbestos Amount (%) |
|---|---|---|
| Water proofing on exterior basement block walls | 900 square feet | 8% |

| Location | Sample Description | % Asbestos | Estimated Quantity | Item | Condition | Sample |
|---|---|---|---|---|---|---|
| Basement Exterior | Waterproofing | 8 | 900 square feet | Cat. II | Good | 11a |

Photograph 9 - View of the west side of the church facing south and basement exterior waterproofing (Sample11a)

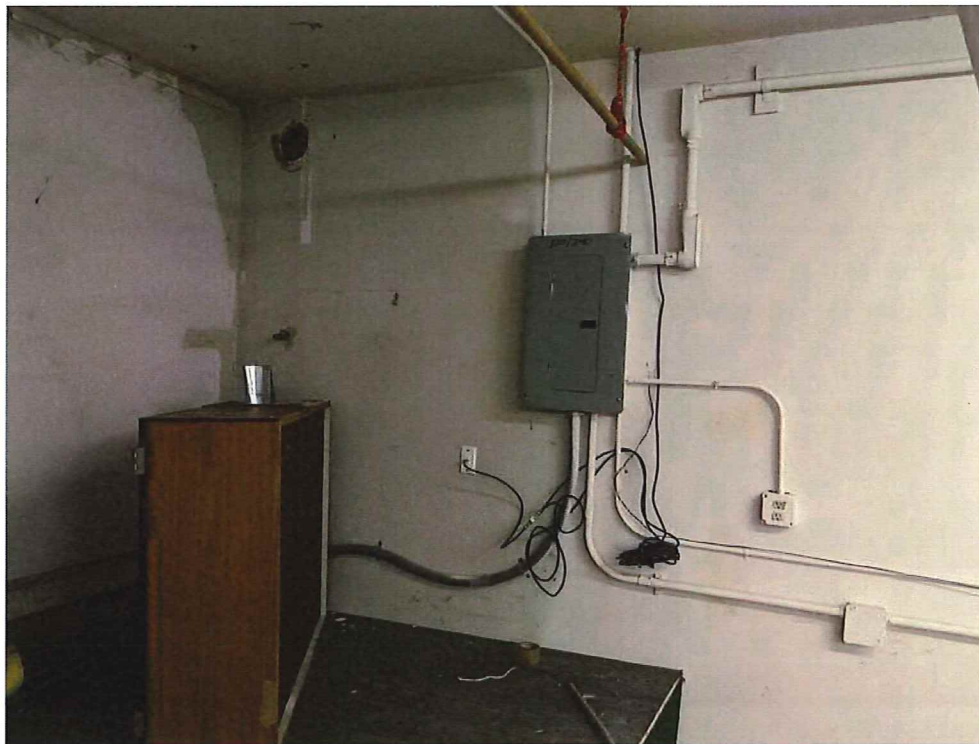
Due to the power still being supplied to the church the old fabric wiring could not be sampled for asbestos. This material must be assumed to contain asbestos until such time that the power can be shut off and samples are collected to prove otherwise.

| Location | Sample Description | % Asbestos | Estimated Quantity | Item | Condition | Sample |
|---|---|---|---|---|---|---|
| Throughout church | Wiring and electrical boxes | Assumed | 400 linear feet | Cat. II | Good | not sampled |

Photograph 24 - View of the electrical panel.

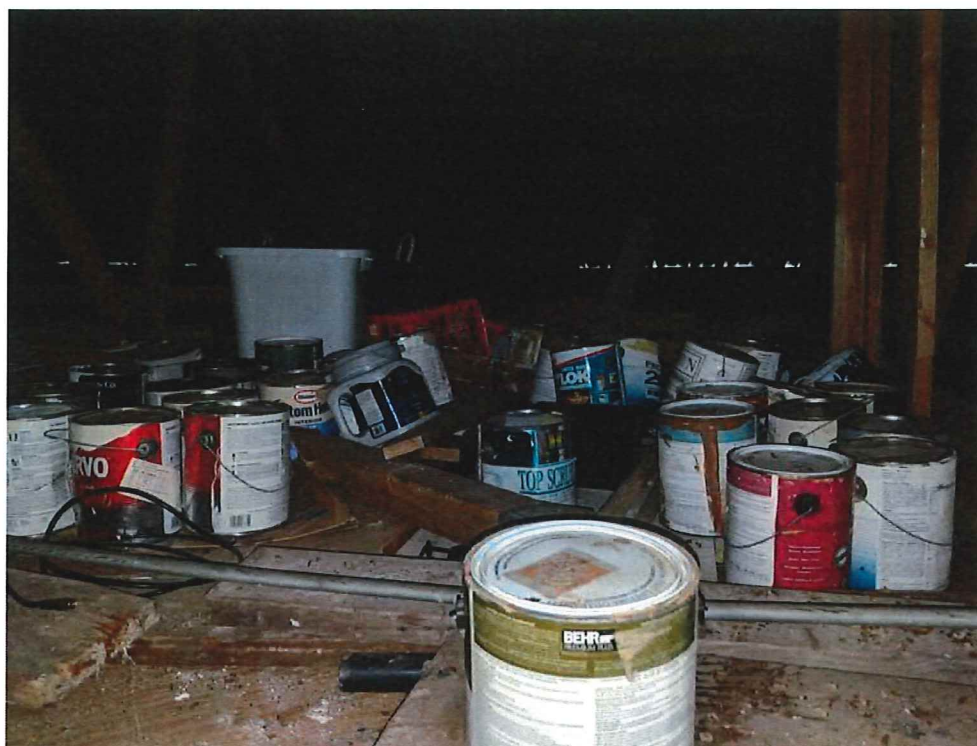
| Item | Quantity | Location |
|---|---|---|
| Paint | 200 gallons | Throughout the building |

Photograph 35 - Paint containers in the garage attic.

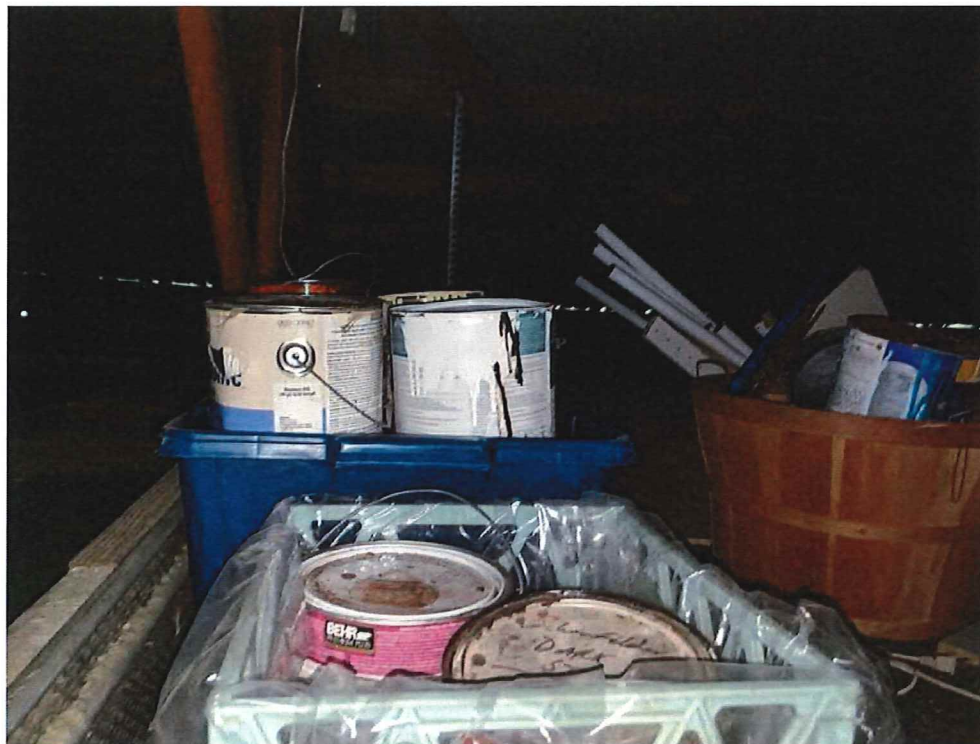
Photograph 36 - Paint in the garage attic.

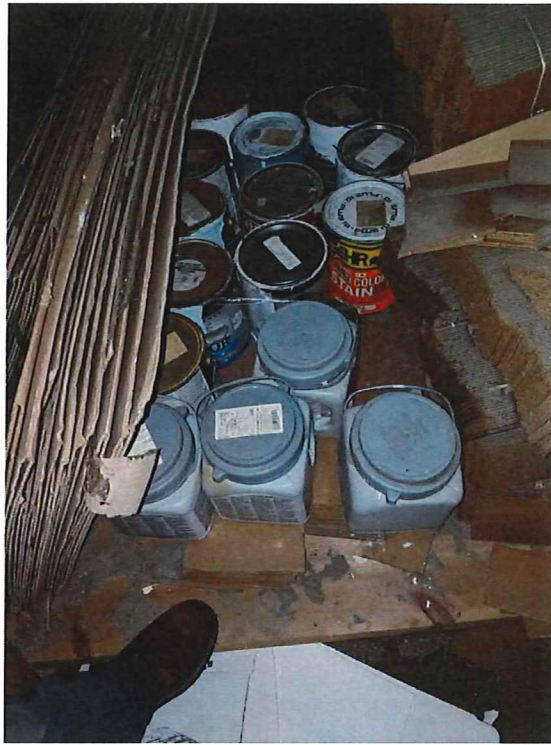
Photograph 37 - Paint in the garage attic.

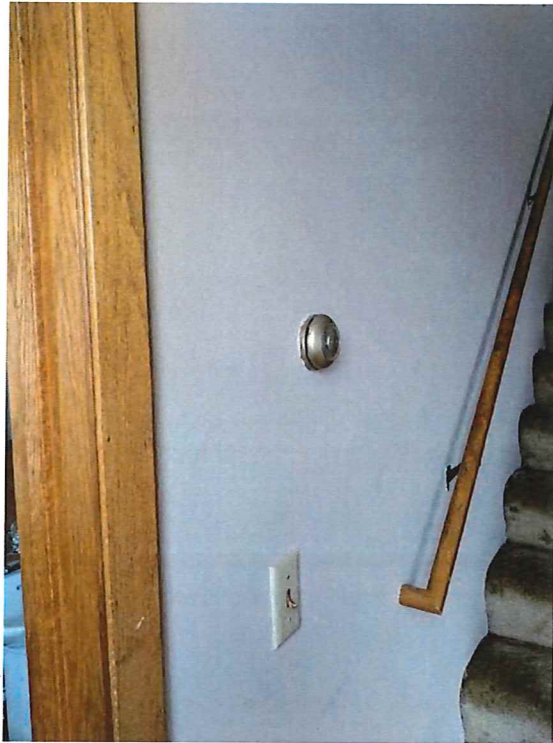
One mercury thermostat was identified during the assessment.

| Item | Quantity | Location |
|---|---|---|
| Thermostat | 1 | Main floor next to bathroom. |

Photograph 45 - View of the mercury thermostat.

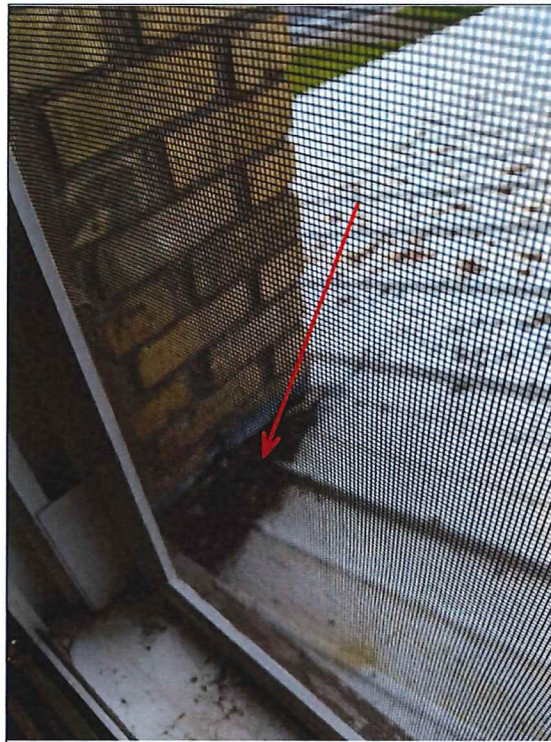
| Material Sampled | Estimate Amount | Asbestos Amount (%) |
|---|---|---|
| Roof patching on chimney | 20 square feet | 10% |

| Location | Sample Description | % Asbestos | Estimated Quantity | Item | Condition | Sample |
|---|---|---|---|---|---|---|
| Chimney on Roof | Patching | 10 | 20 square feet | Cat. I | Good | 09 |

Photograph 52 - View of the chimney tar patch on the roof (Sample 10).

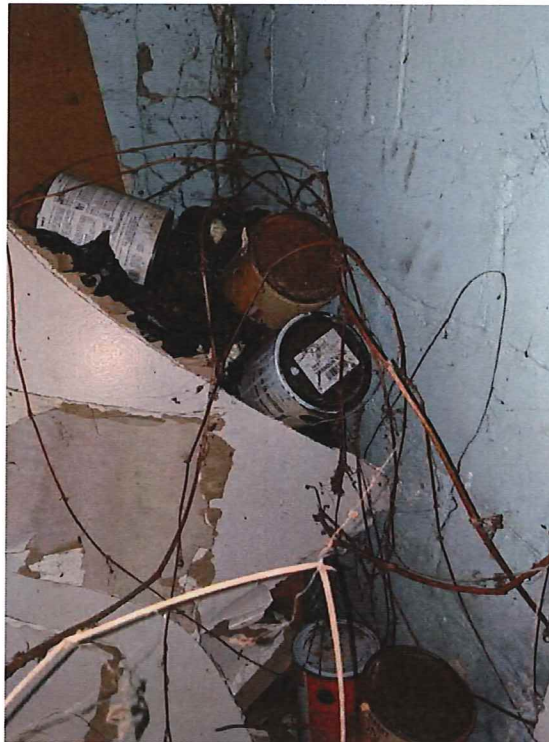
Photograph 60 - View of the paint cans behind the bedroom wall in the basement.

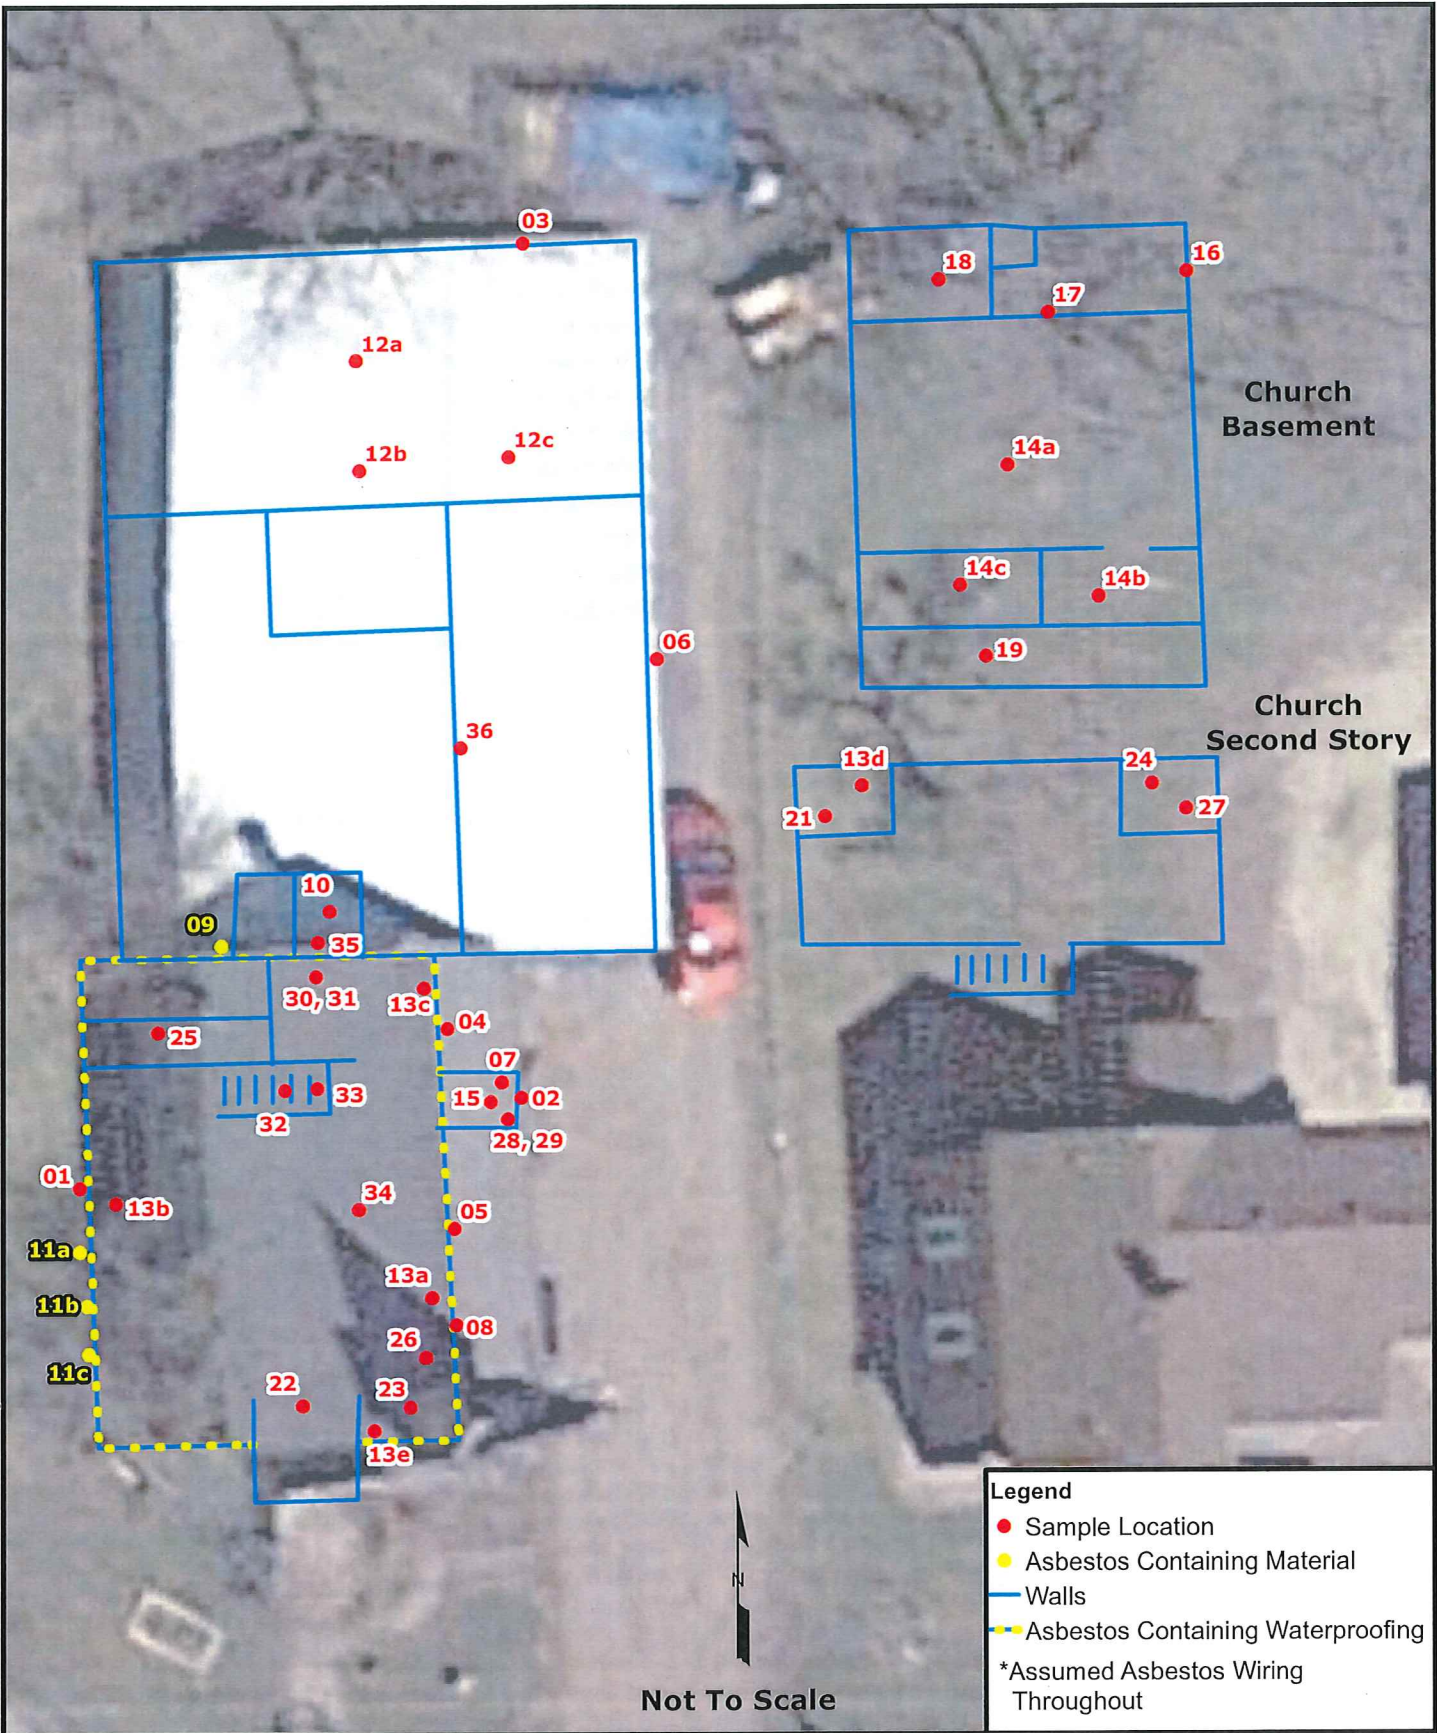
As-built drawing were not available for review prior to the inspection. Previous asbestos inspection reports were also not available for review. Access to the entire structure was obtained during the inspection. A site figure depicting the sample locations and locations of identified asbestos containing materials can be found in Appendix C.
