SAINT FRANCIS **PUBLIC WORKS**

2022 ANNUAL REPORT

PUBLIC WORKS

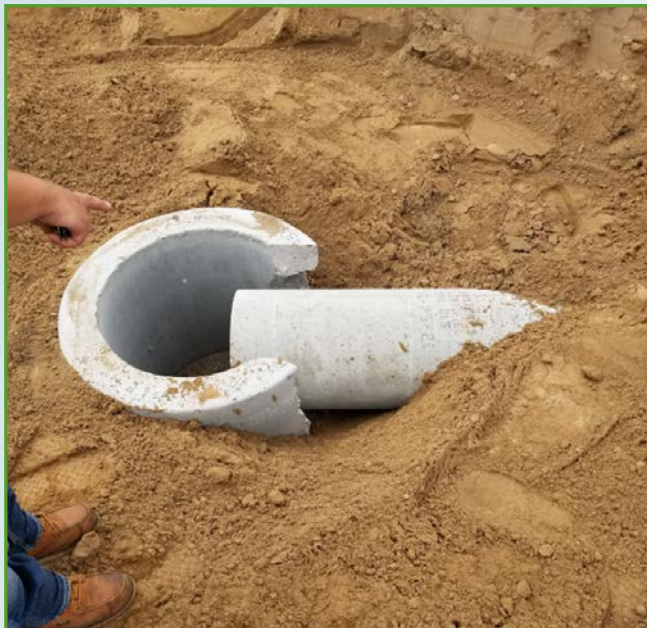
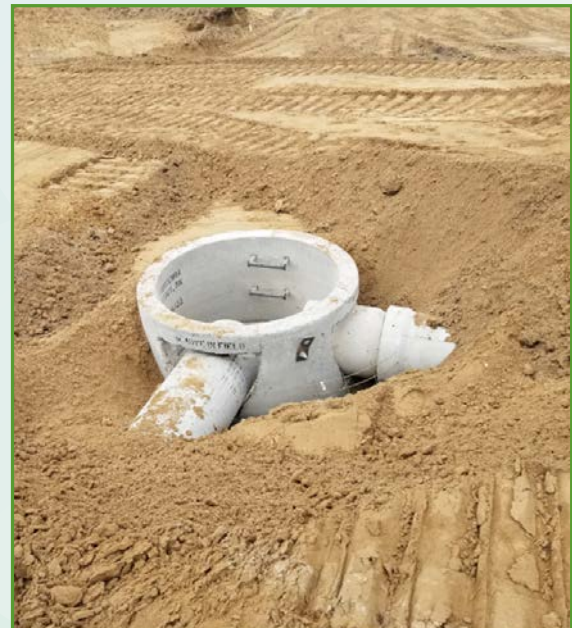
Siwek Park storm sewer installation.

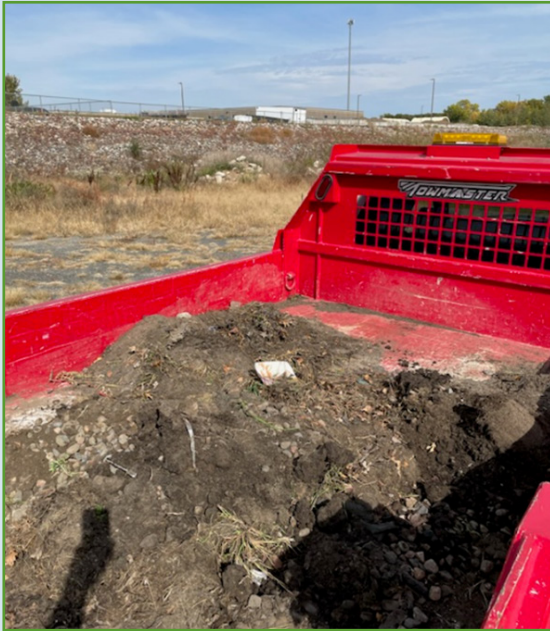
Annually, our PW Crew cleans out storm drains that have any debris or vegetation coming out of them.

Large Storm Weir or Stormceptor on River Drive — Cleaned out! We retrieved over one ton of sediment and debris while cleaning this stormceptor alone! We had about three tons from all the other storm drains we cleaned in the city as well.

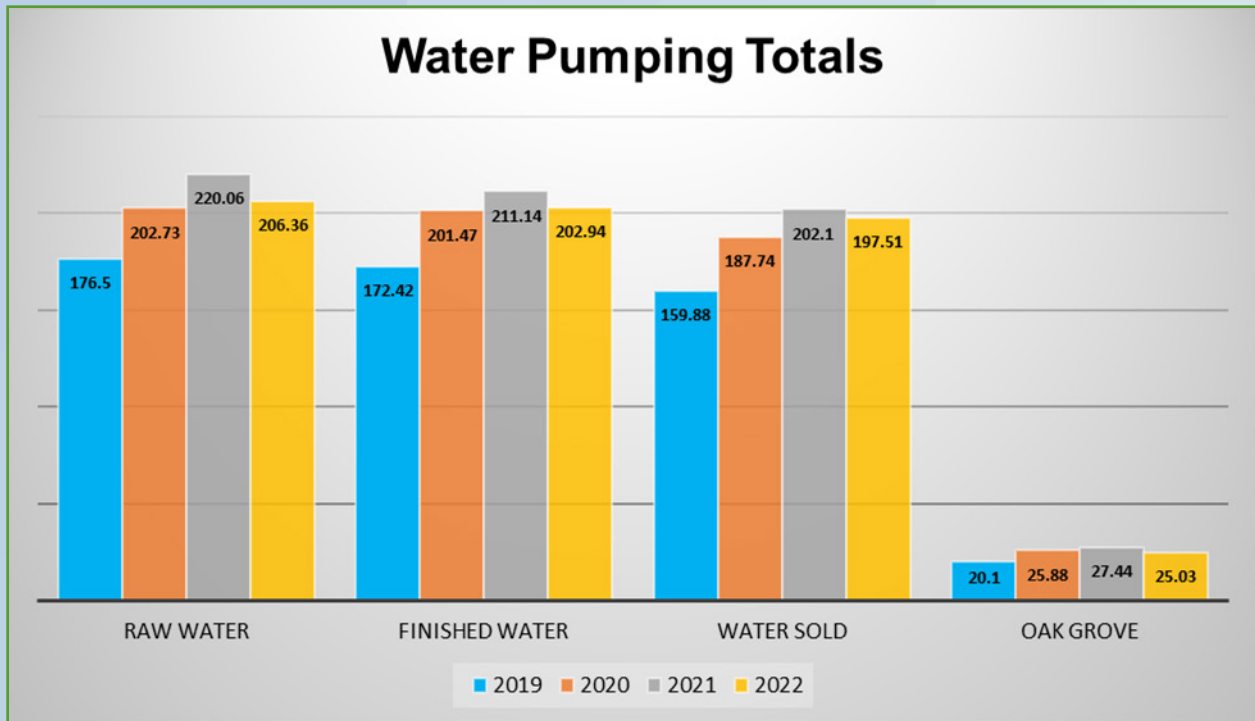
Figure 1: comparison of pumping totals and water sold, in MG.

As you can see from the figure 1, our pumping numbers have decreased for 2022. We saw a 7% reduction for raw water and 8% reduction for Finished water. Something to keep an eye on as we roll into spring next year is drought conditions. We are currently in a “Moderate” drought classification for our area, even after all the moisture that we have received this fall and winter. This condition could improve or get worse and we will continue to monitor as we go along.

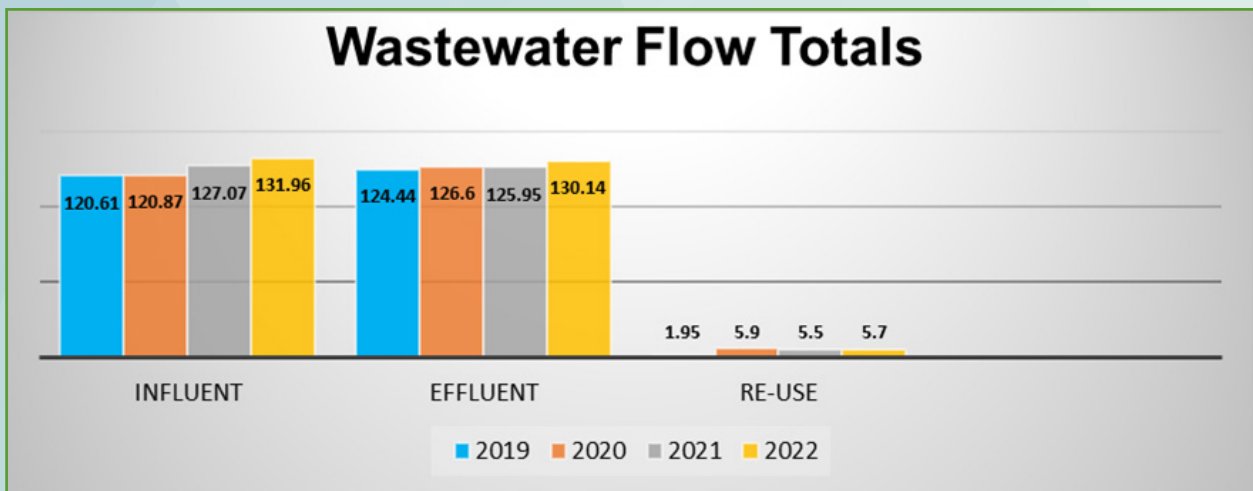
Figure Above: Flow data for the last four years in million gallons.

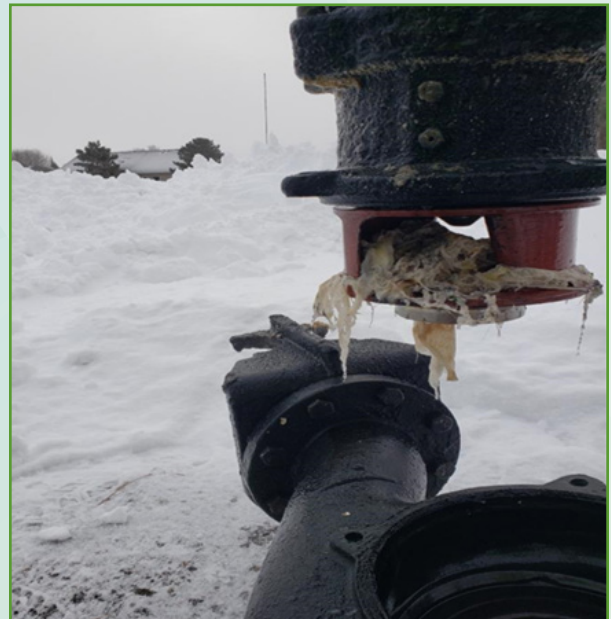
The never-ending battle with “Flushable wipes” never ends! When we say that a pump is plugged, the image to the right is what we are referring to. Wipes and other debris wind up within the impeller, which can cause a drastic pumping deficiency. Most of the time, staff can free the plug loose by pulling on it. Other times require a cutting device, a pry bar, and channel locks.

When the impeller becomes too entangled with rags, it causes the amps to rise, which can lead to the pump tripping out the breaker or in some complete pump failure.

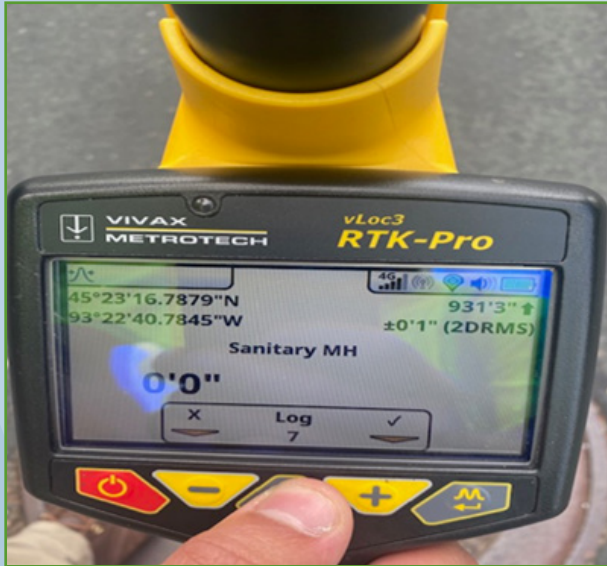
The picture to the left shows the interface of the RTK locator and the data it collects. The problem that we had was what to do with the data after collecting it.

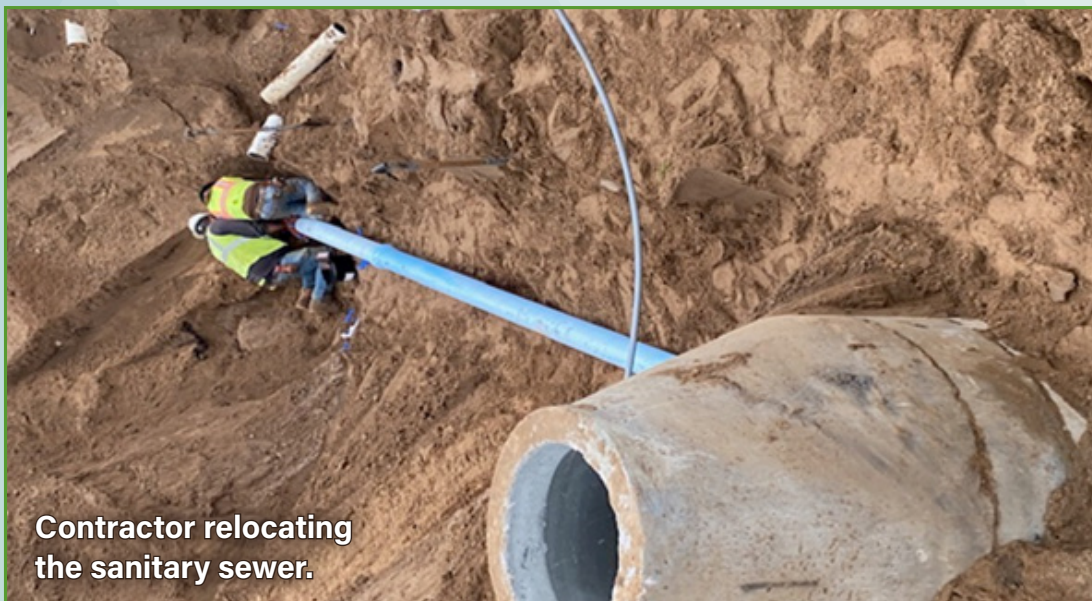
Contractor relocating the sanitary sewer.

The Poppy Street reconstruct was completed this year. Work entailed replacing roughly 1000 feet of undersized water main, the addition of new gate valves and hydrants and the relocation of sanitary sewer. The other obvious benefit was the new roadway!

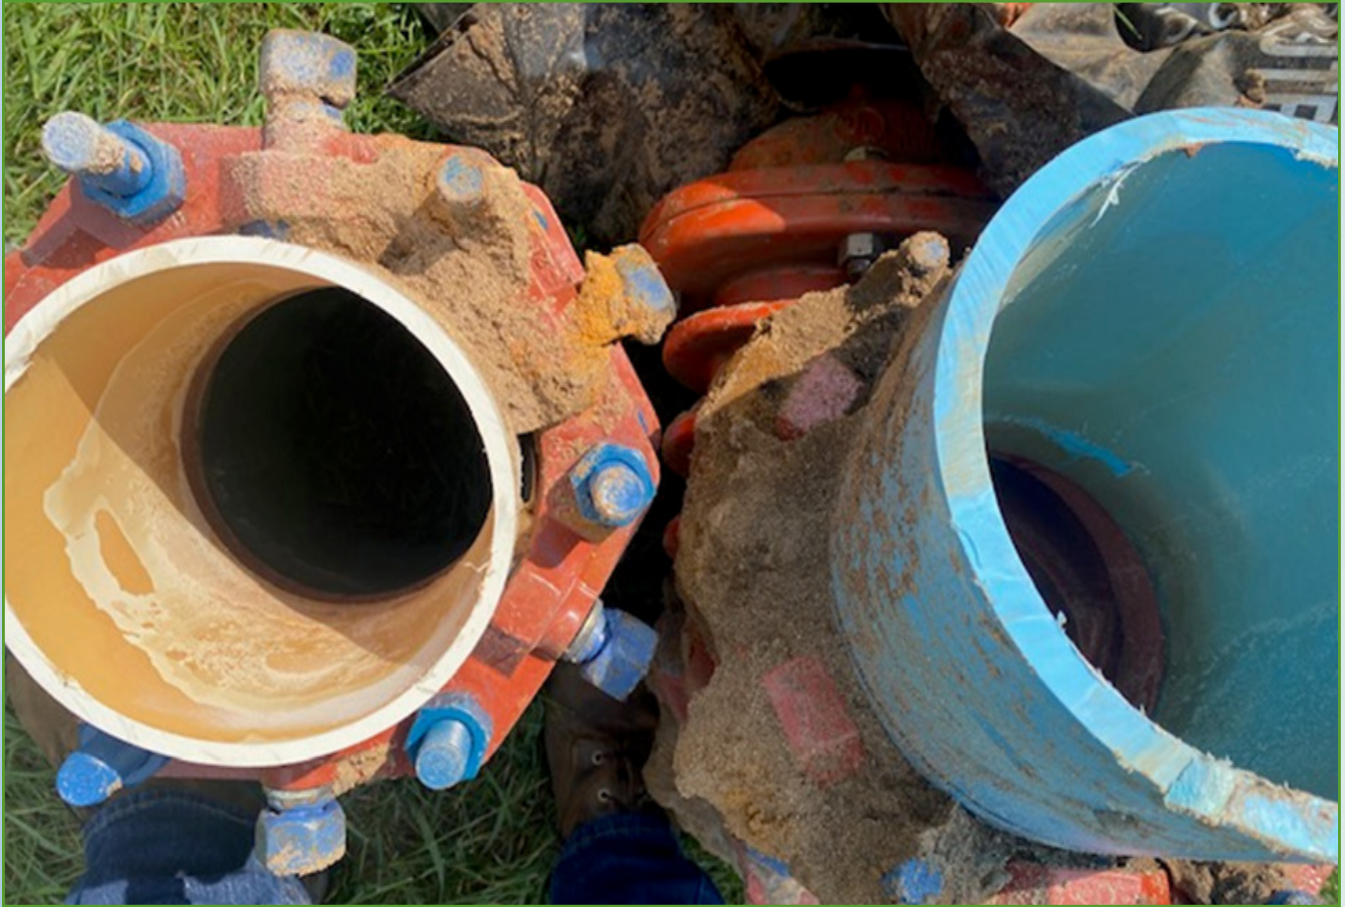
Below, is the 6" pipe on the left, and the new 8" pipe on the right for the Poppy Street project.

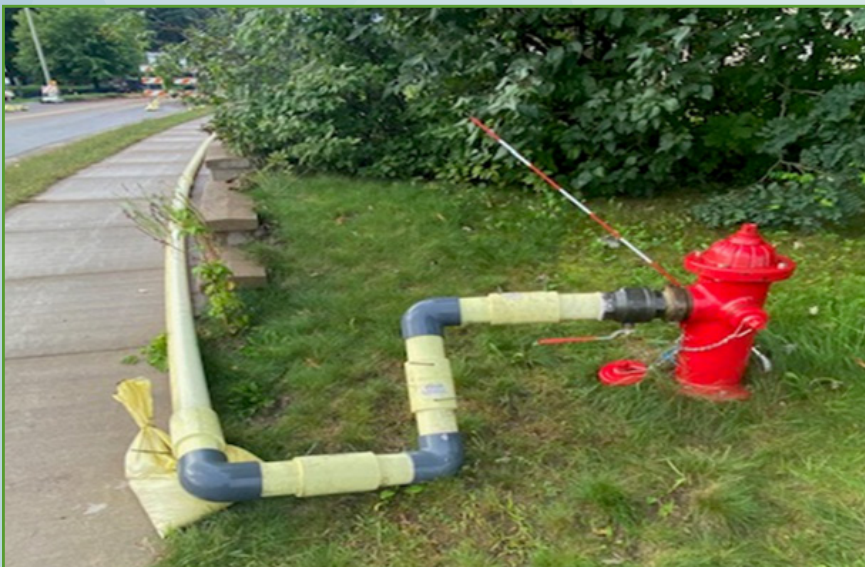
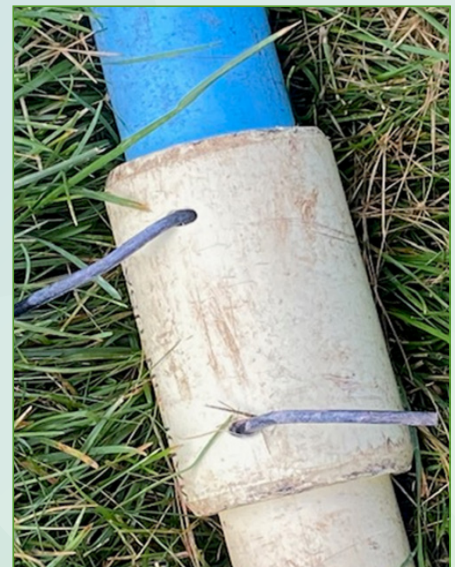
The picture above is the 4" temporary water line that supplied the water to the development during the installation of water main. Early on, we did experience one fail with a slip joint creating no water for residents. The contractor was on-site and had it repaired in a timely manner.

This slip joint failed and the two wires that held it together broke.

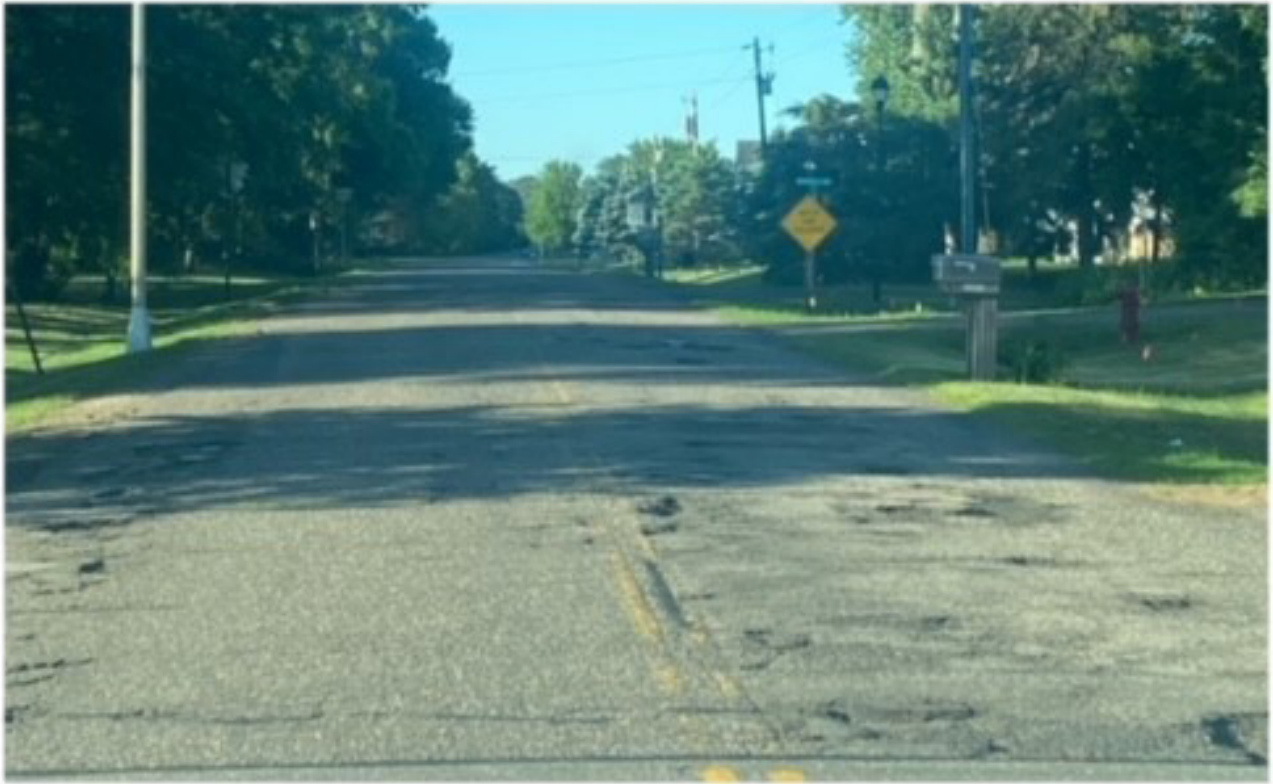
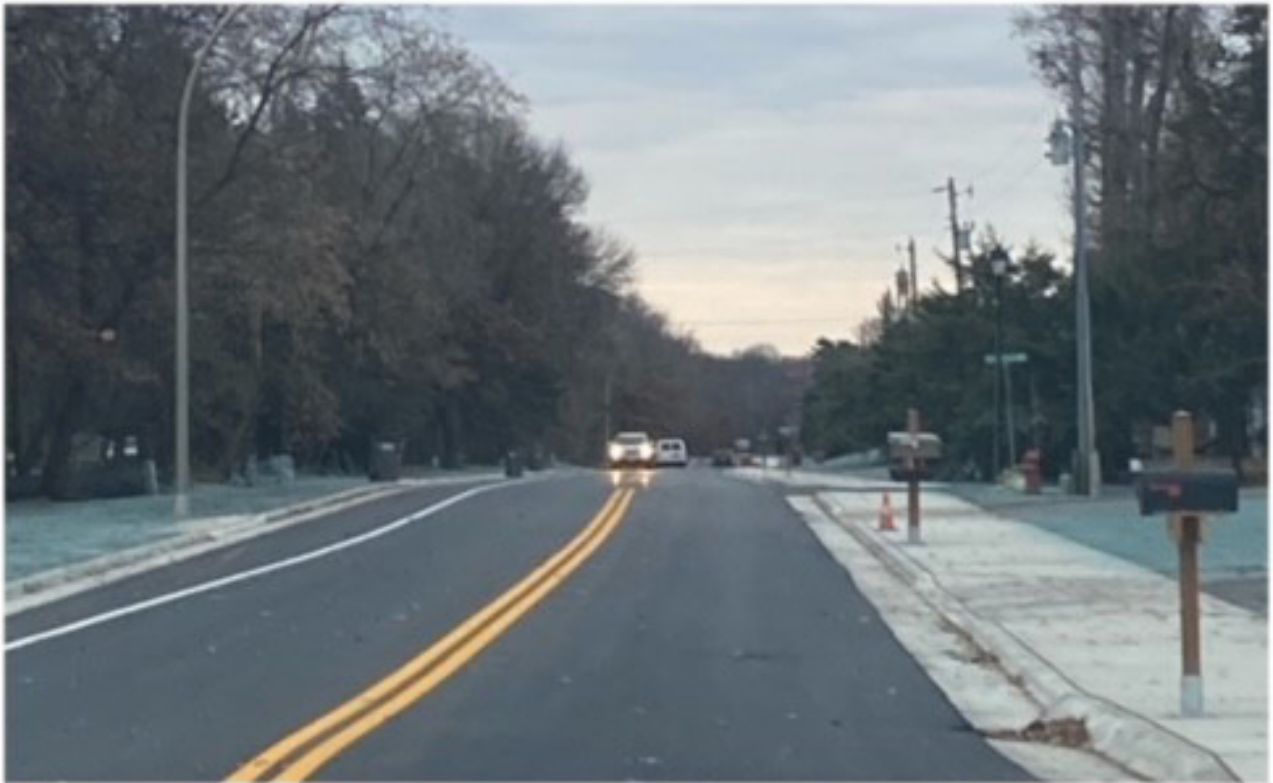
The Poppy Street before and after taken in roughly the same location! What a difference!

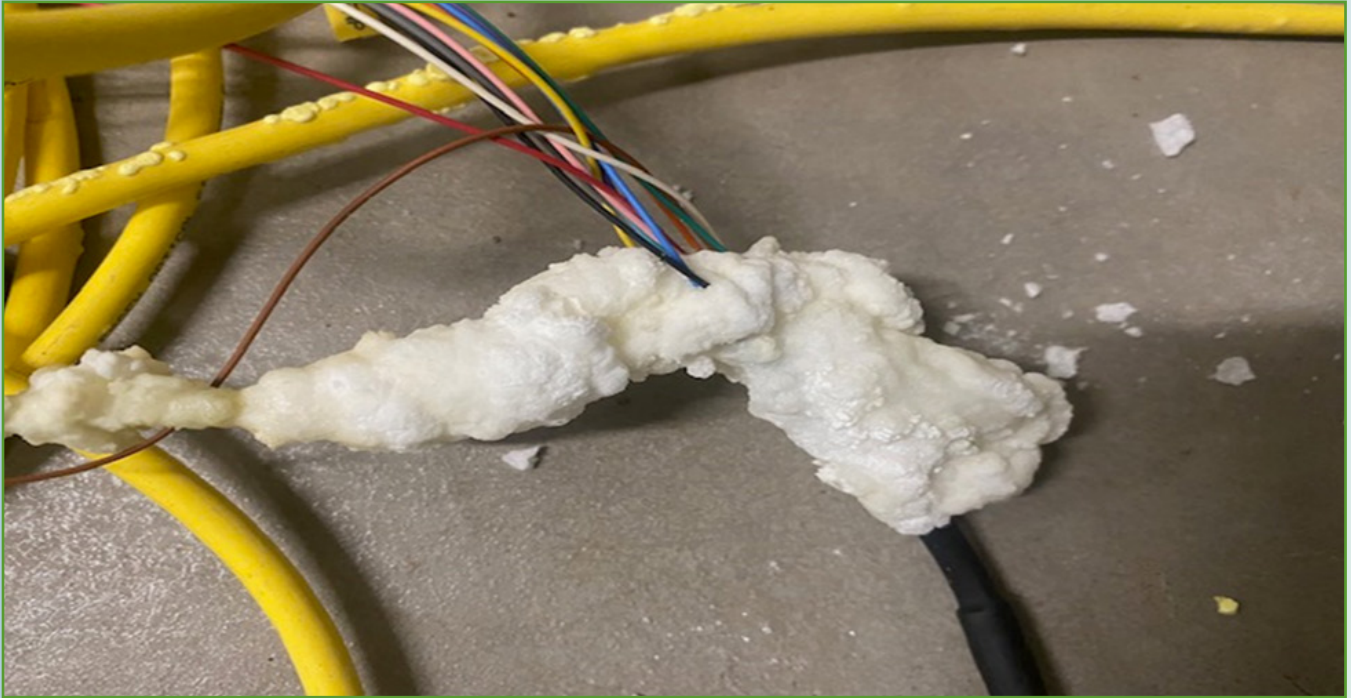
Staff along with our SCADA integrator replaced the fiber optic cable that completes a loop between all facility buildings. Water had infiltrated the sheathing and was causing a calcium like material to wick out from the cable. The fear was that it would eventually snap the fiber causing complete failure.

Although the fiber never completely failed, we did experience connection issues that were causing intermittent communication disruptions between the buildings.

The new upgraded fiber has much thicker sheathing.
